PORTS OF JERSEY

INDEPENDENT INVESTIGATION REPORT: JERSEY LIFEBOAT ASSOCIATION GROUNDING

Report Number: 21UK1819
Issue: 01
Date: 2 February 2022

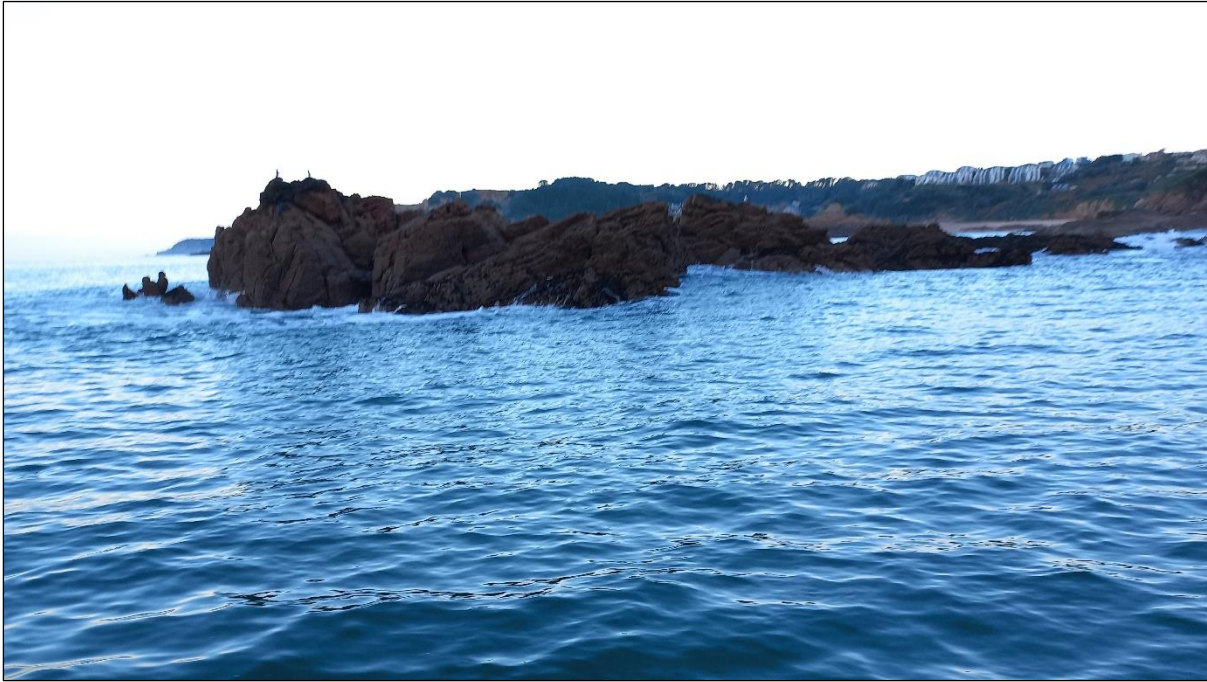
Figure 3: Pierre Au Poisson Rocks.

22:05 At this time the coxswain asked the navigator to set up a full route to obtain an accurate ETA. The navigator tried to build up a fuller route to the destination but the functionality of building a route on the chart plotter to the casualty was not given as an option which rendered him confused. The navigator therefore attempted to set the waypoints in manually and build up a route from the beginning. During this time the coxswain became distracted and lost his spatial awareness as he turned round to discuss the situation with the navigator. It was at this point that the coxswain made two unintentional small turns to starboard that went unnoticed. The chart plotter was turned to face forward so the coxswain could observe the chart plotter, the chart plotter was set to day mode therefore the glare of the plotter further restricted the coxswain's night vision. It was at this point that the *Sir Max Aitken III* made contact and grounded on the Pierre au Poisson rocks (**Figure 3**).

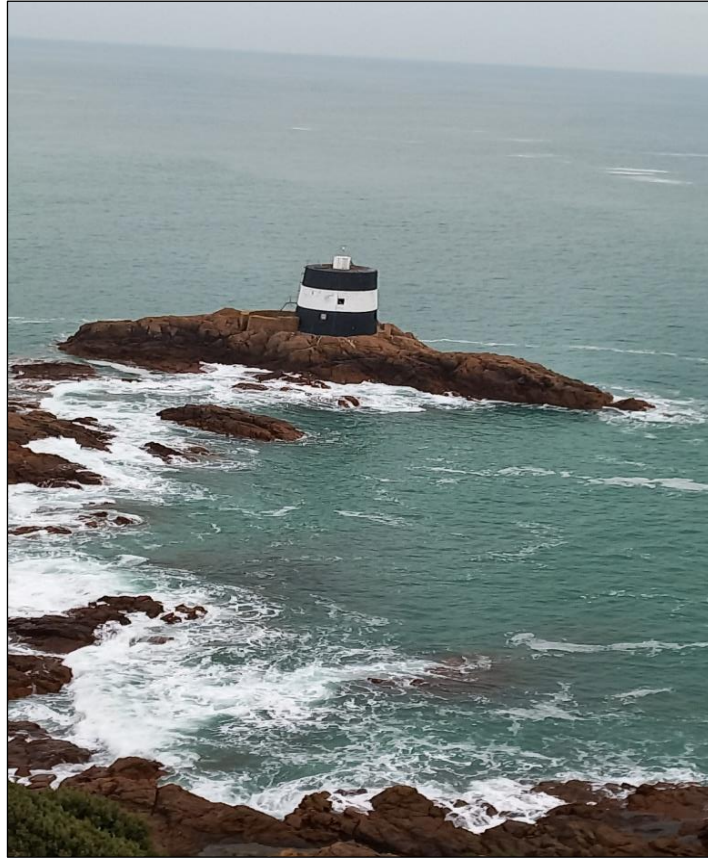
Figure 4: Noirmont Point

22:10 *Sir Max Aitken III* contacted JCG on VHF 82 stating that she had made contact and grounded with the Pierre au Poisson rocks south of Noirmont Point (**Figure 4**).

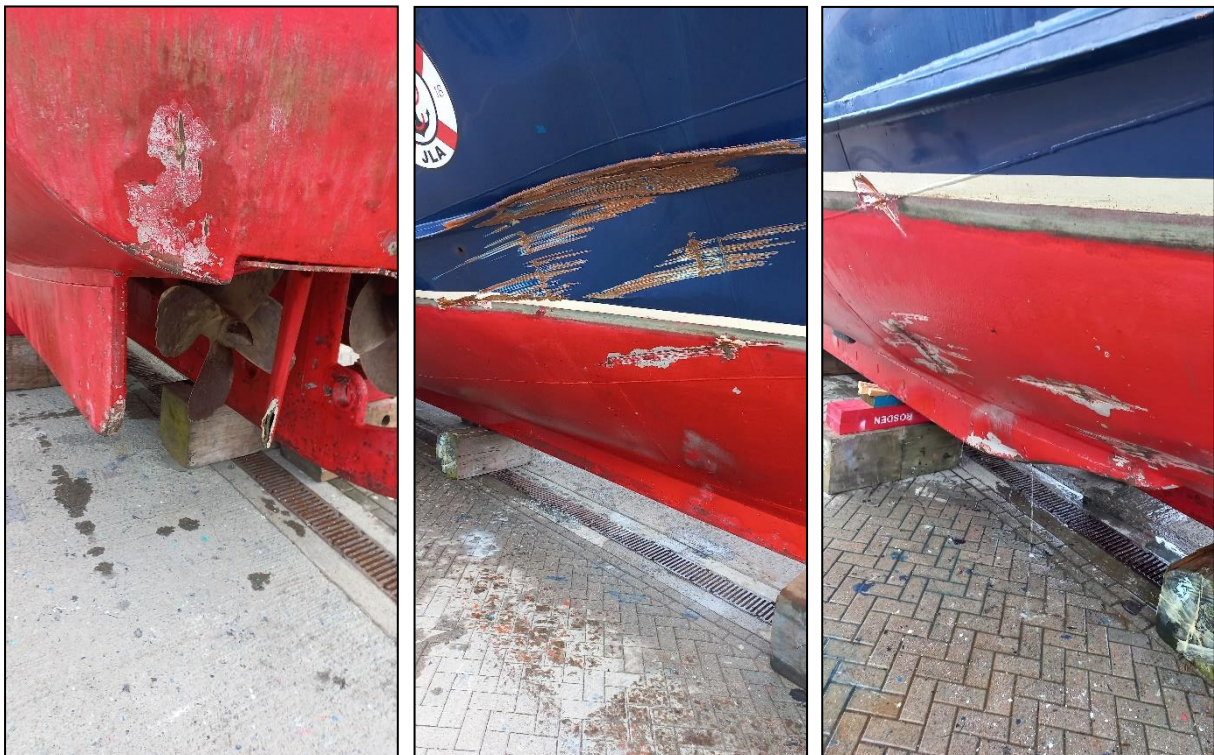
Figure 6: Damages to the JLA Sir Max Aitken III.

22:14 *Sir Max Aitken III* contacted JCG on VHF 82 stating that they were assessing the damage, but no water ingress, no pollution, no persons injured, rudder damaged but operational with both propellers in working order and no further assistance was required.

22:14	<i>Sir Max Aitken III</i> contacts JCG and informs them that they had assessed the damage, no water ingress, no pollution, no-one injured. One port rudder had been damaged but the starboard one was still operational as were both ME.

Own vessel	<p>Damage included:</p> <ul style="list-style-type: none"> - Bent hull on both starboard and portside (no hole and no water ingress) - Portside rudder inoperational (starboard side rudder fully operational and not damaged) - Portside propeller dented blades (both propulsion working at near full capacity) - Both bilge keels damaged - Above waterline starboard belting (steel made) damaged
Second vessel	N/A
Object	N/A

Due to the defects, it was not possible to repair the vessel in Jersey due to no specialist repair companies, and therefore the vessel was required to sail to the UK mainland for repair. The vessel has been prepared for the voyage. This was composed of:

- Setting the port rudder fixed in place at amidships;
- Propellor damage has been smoothed; and
- The bilge Keels have been filled with polyester resin filler.

A short-term single voyage conditional certificate for a single voyage to a repair yard was issued subject to a satisfactory sea trial, as confirmed by a MECAL surveyor, with agreement to limiting wind/sea conditions forecast for the voyage.

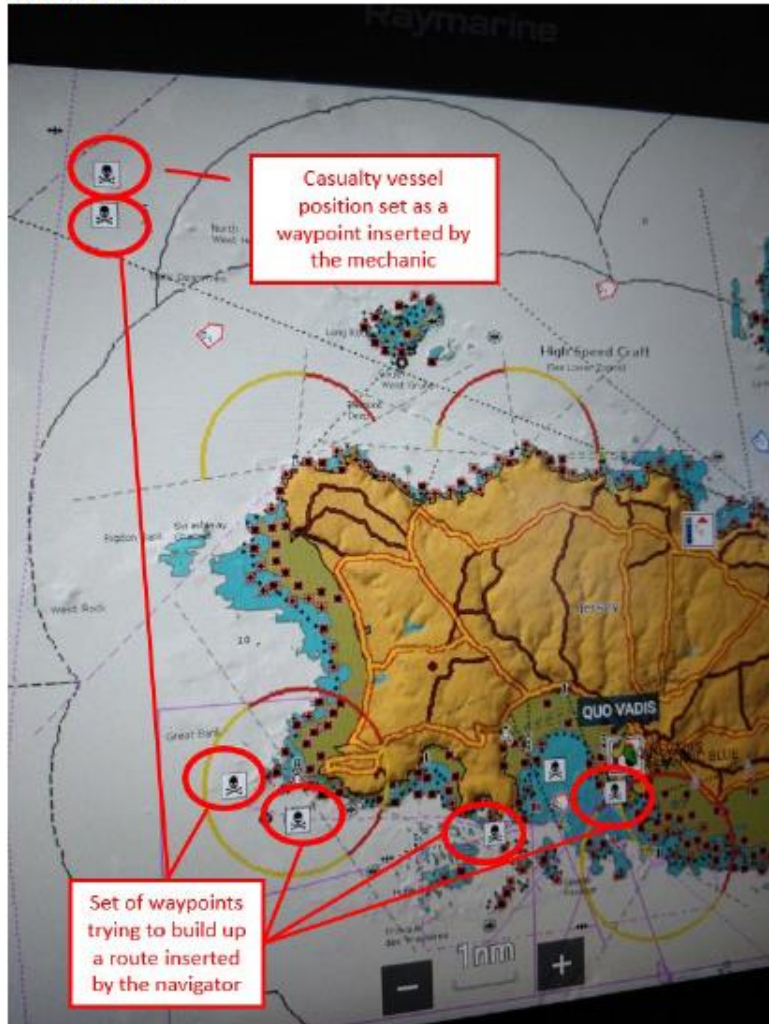
Picture 1: casualty position and route in progress at moment of impact

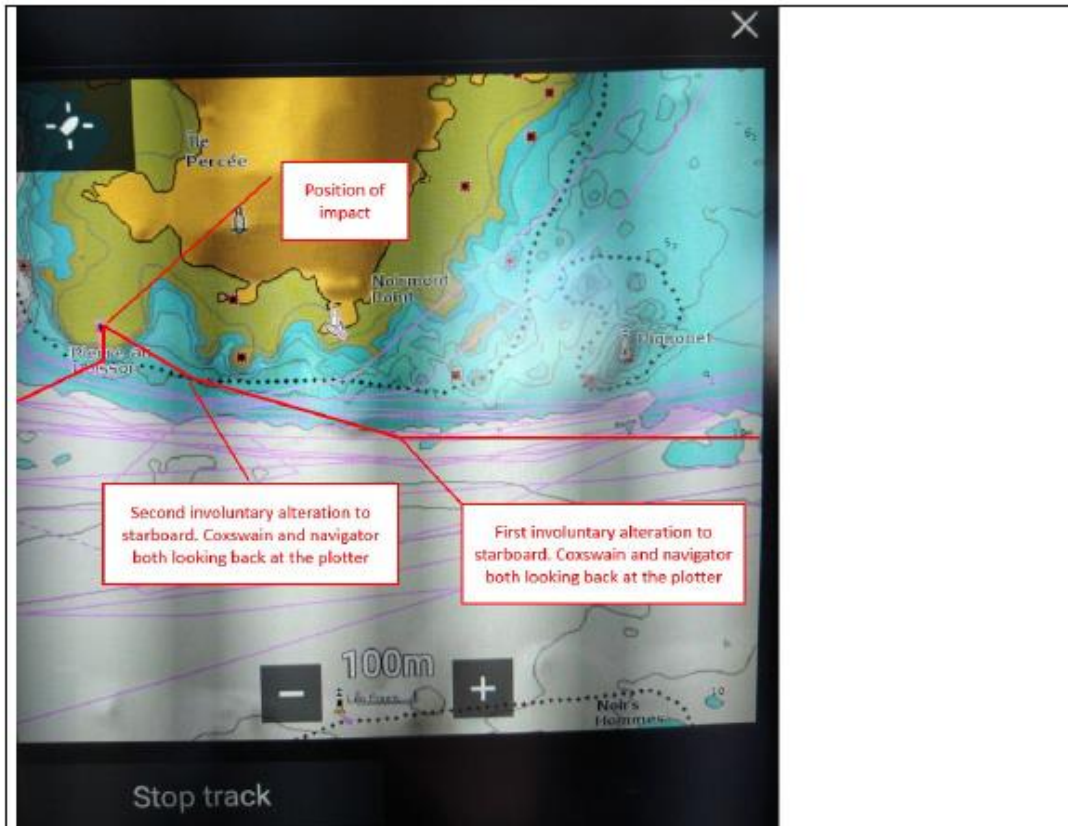
Picture 2: route followed before and after moments after impact
