SITE VISIT REPORT

Project Name: Brooklyn Mews
Project No: 60163
Building Application No: B/2020/0584/
By: [REDACTED]
Date: 09/09/20
Weather: Sunny
Reason for visit: Check existing rafters on Unit 5.
Present: [REDACTED] (Kalmac), [REDACTED] Architect).
Distribution: [REDACTED] (BCO), [REDACTED] (Client)
Remarks:

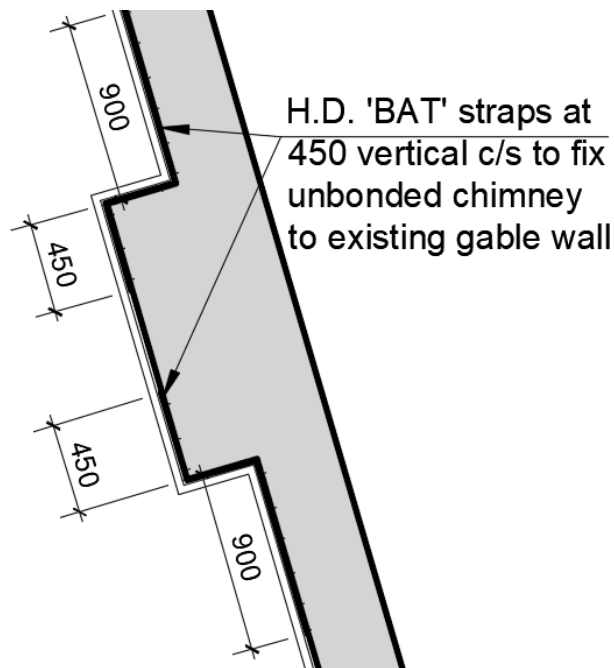
- Existing gable wall at unit 6 has an unbonded chimney stack at second floor level. Refer to photographs 1 & 2. As repair works it is proposed to fill the gaps with mortar and install heavy duty straps as per the sketch below.

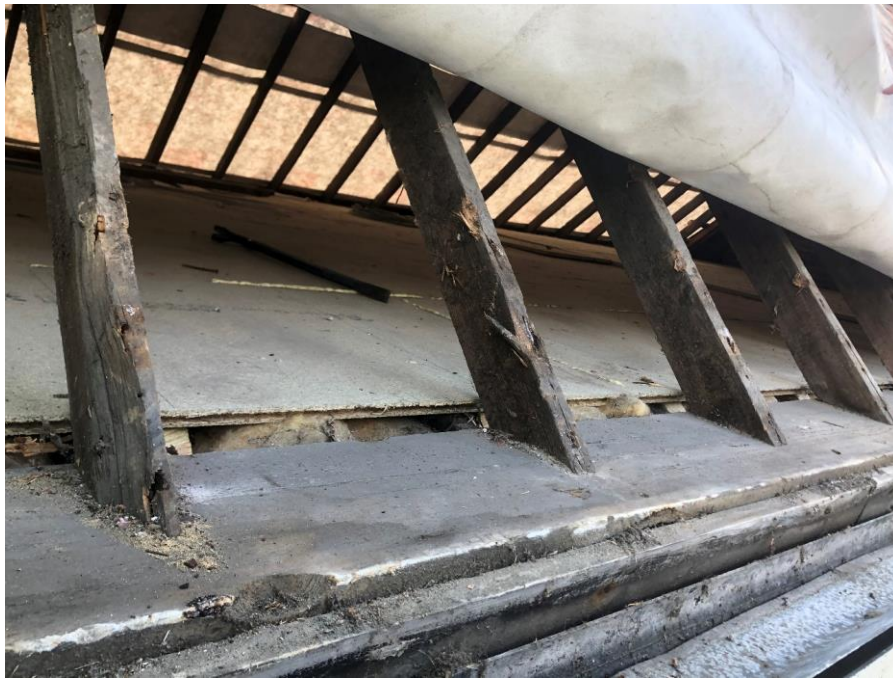
Photograph 3

- Existing rafters at unit 5 are in poor condition. Refer to photograph 3. Therefore new 150 x 50 rafters at 400 centres are to be installed between the existing rafters. Most likely, this will be the case for the other units 4 to 1, to be confirmed on site.
