**MARITIME INCIDENT
INVESTIGATION REPORT INTO THE
Serious Marine Accident (during
egress via adjacent vessel)
Small Commercial Vessel
'Normandy Trader'
21st NOVEMBER 2024**

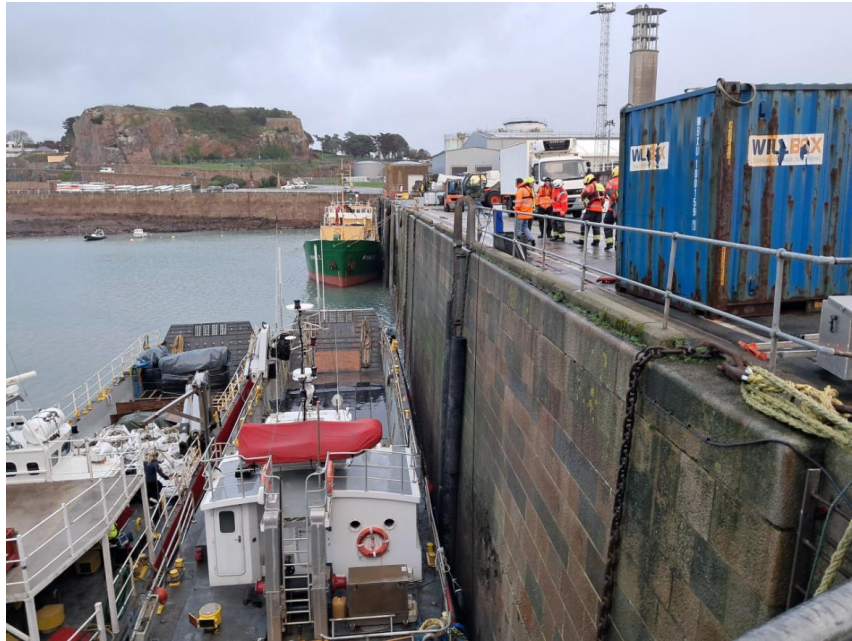
FIG 1 - Vessels alongside: Ronez (East Cross), Normandy Trader (outboard), Normandy Warrior (inboard) & Access Ladder

2.4 After an uneventful voyage, NORMANDY TRADER was all fast on the West Cross Berth, Victoria Pier, St Helier at 1500 UTC on 21st November 2024. NORMANDY TRADER berthed Starboard side to and outboard of MV NORMANDY WARRIOR (both vessels 'bows East'). MV Ronez, a 60m long specialised cement carrier was occupying the adjacent East Cross Berth on the same quay. (See FIG.1)

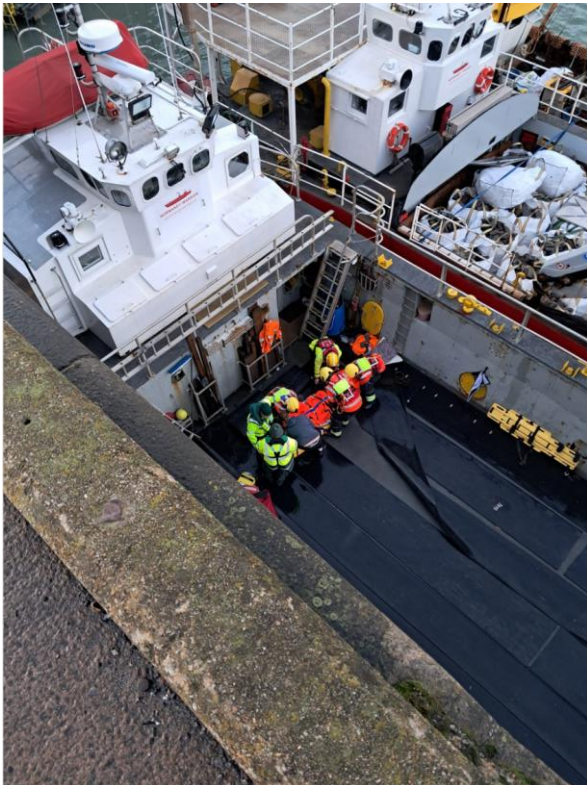
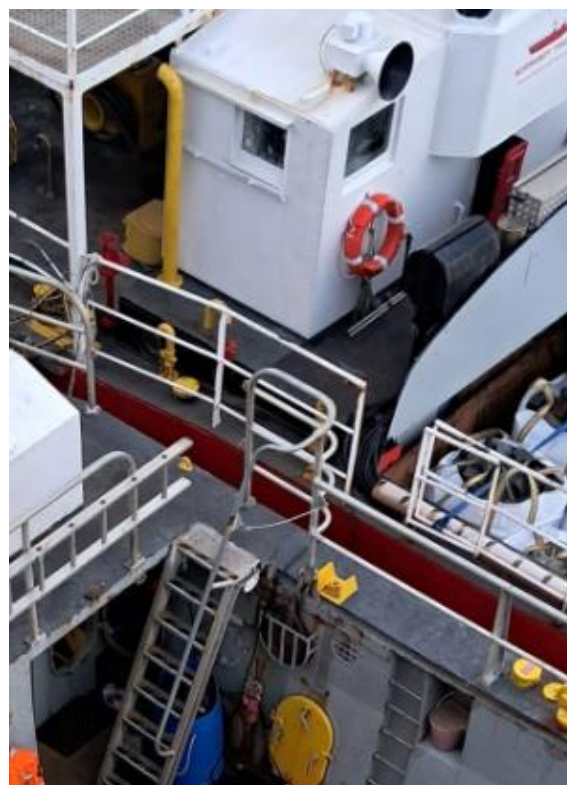
FIG 2 - Access between vessels – FIG 2a

2.13 At this point the Skipper descended the ladder to assist. He made the Deck Rating secure on the ladder and assessed his responsiveness and pain level. He then assisted the Deck Rating to ascend the ladder while keeping the NORMANDY WARRIOR off the quay, until both were able to adopt a seated position on the vessel's rubber deck-edge fendering. (FIG 2A & 4)

2.14 Following rest and a further assessment, during which the Deck Rating's rucksack, wet outer clothing and certain other items were removed, the Skipper assisted the injured Deck Rating aboard the NORMANDY WARRIOR just forward of the wheelhouse (FIG 2).

2.15 The Skipper then assisted the Deck Rating, with some difficulty, to the NORMANDY WARRIOR's cargo deck using the fixed access ladder (FIG 2A). The Skipper's initial intention was to assist the Deck Rating into the accommodation to remove further wet clothing and keep him warm. This plan was however reassessed due to the Injured Person's significant pain level and in order to minimise the difficulty for his eventual extraction. Instead, the Skipper concentrated in making the Deck Rating comfortable and keeping him warm, placing a cushion on deck for insulation and utilising a TPA, the Skipper's own waterproof jacket, towels, and an umbrella (it having started to rain once more). Due to the prompt action by the Skipper this whole process was completed in approximately five minutes. (FIG 3B & FIG 4)

6.8 Although NORMANDY TRADER and NORMANDY WARRIOR had identical hull dimensions and were under the same ownership the layout of their deck railings at the bridge deck were different and the access gate on NORMANDY TRADER did not align with the gap in the railings of NORMANDY WARRIOR when the vessels rafted up. This made transfer between the vessels using the 'step across' method more hazardous than would otherwise be the case as it required the crew members to climb over one set of railings to cross between the vessels. (FIG 4A)

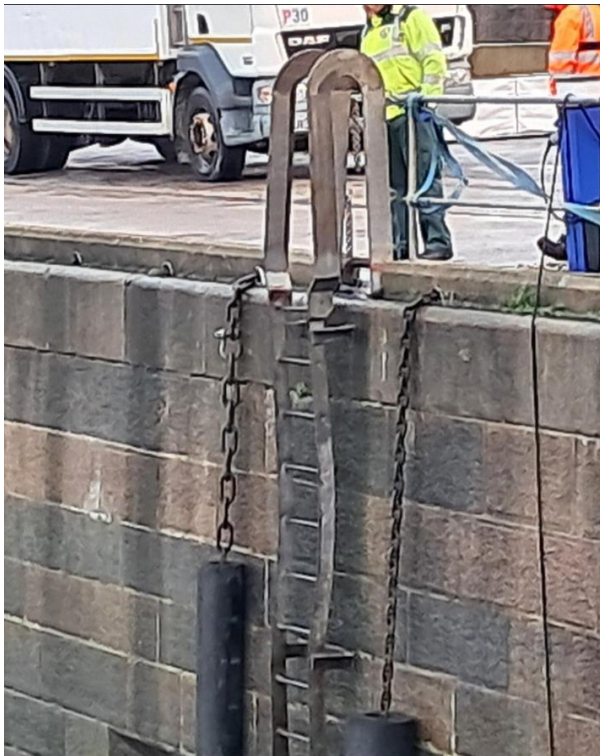
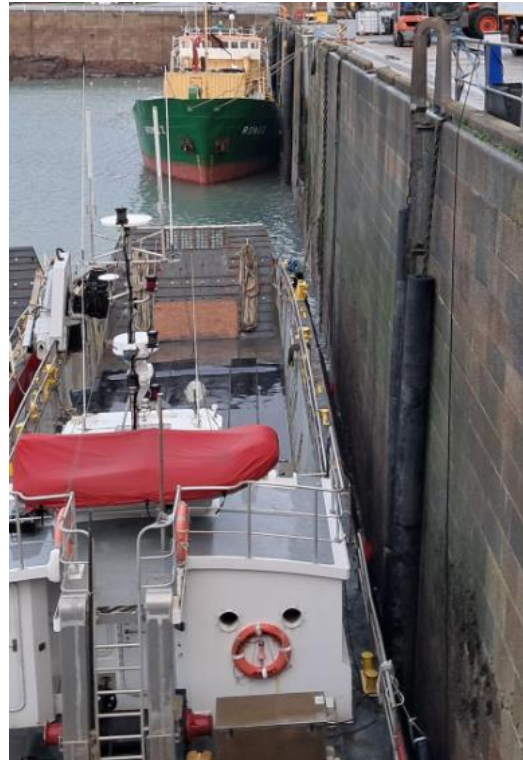
FIG 3 – Ladder Access to the Quay – Fig 3A

2.8. Once aboard the NORMANDY WARRIOR further disembarkation to the top of the Victoria Quay was via a fixed vertical steel ladder (See FIG 3 and FIGS 3A to 3C). This ladder was one of five similar vertical ladders on the Victoria Quay, two of which were associated with Landing stages with fitted platforms at 6m and 9m above chart Datum (half-tide, and $\frac{3}{4}$ tide for spring tides). The construction of the ladder concerned approximated to the Design Standard Guidance with respect to styles, tread width, diameter, and separation, and the separation of fixing brackets. Protection for the ladder was provided by chains supporting vertical rubber tubular fenders on the quay edge on either side.

6.11.1 The ladder is protected by vertical cylindrical rubber tubular fendering hung from chains (Fig 3) the fendering when installed was of different sizes with smaller diameter fenders on the Eastern side which do not provide as much protection (see 6.11.3 below).

6.11.2 As is clearly illustrated in FIG 3 there is a gap in the ladder's fendering with the top five rungs on the Eastern side and the top eight rungs (just below the second mounting bracket) on the Western side left unprotected.

6.11.3 As a consequence of 6.11.2 above (see FIG 3 and FIG 3B) previous vessel contact in way of approximately the third and fourth steps from the top had slightly indented the ladder so that the second to sixth steps were slightly out of alignment to the vertical. This damage was considered minor and, as it had left the ladder both safe and usable, had not been reported by either the operators or the crew of NORMANDY TRADER or NORMANDY WARRIOR or during routine inspections by Ports of Jersey staff. It is not considered that the above minor damage contributed to the accident.

6.11.4 The ladder was attached to the quay by steel fixing brackets of angled steel at intervals within the suggested 2460mm separation. (FIG 3 and FIG 3B) The flat horizontal face and right-angled profile of these brackets, coupled with the smaller diameter fendering on the Eastern side of the ladder, were reported to have caused damage to spherical inflated fenders used on NORMANDY TRADER and NORMANDY WARRIOR in the past. It should be noted that no such reports had been received prior to the accident.

8.2.1.1 Carrying out any necessary repairs to the securing of the lower part of the westernmost ladder and if necessary to the distortion of the upper rungs, or replacing the ladder concerned.

8.2.1.2 Improving the fendering on the westernmost ladder to cover the full tidal range and replace the fendering on the eastern side with cylindrical tubular fenders of the same diameter as those currently fitted to the western side

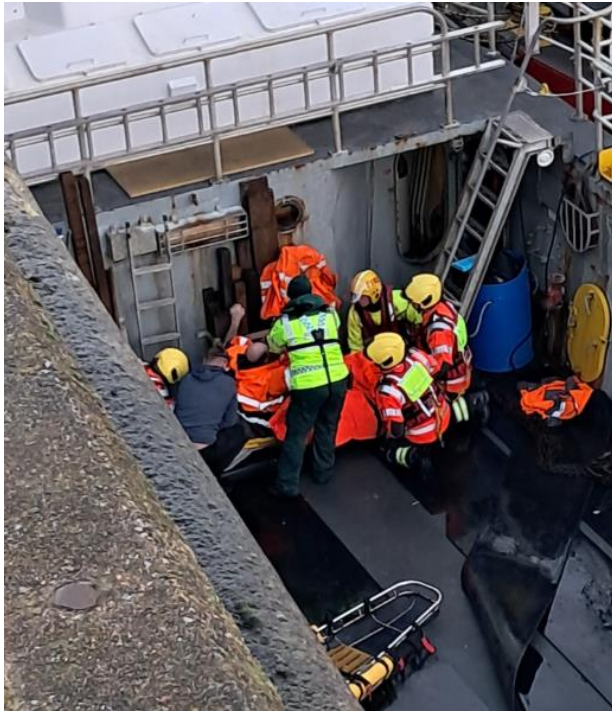
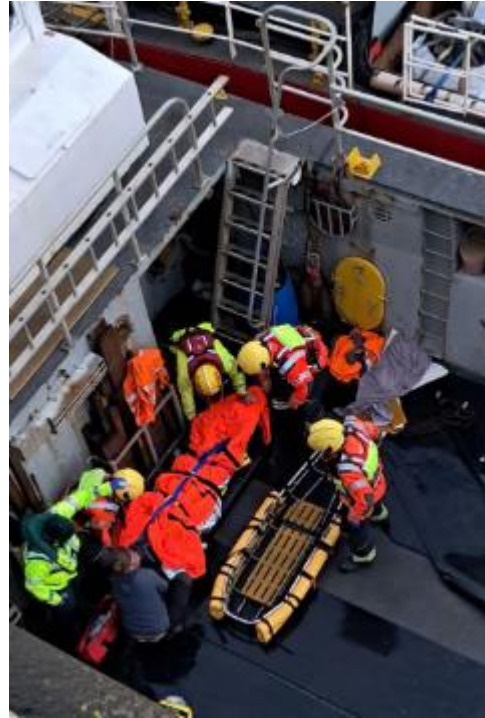
FIG 4 – Evacuation of casualty – FIG 4A

2.18 The Skipper then lowered the NORMANDY WARRIOR's bow ramp and briefed the Fire Service and Paramedics on safe transfer across the ramp and securing of the IRB (FIG 5). The casualty was transferred to a stretcher and then via the IRB to the shore and the waiting ambulance. (Completed by 1624 UTC) (FIG 4 and 4A to 4C) All units were stood down at 1633.

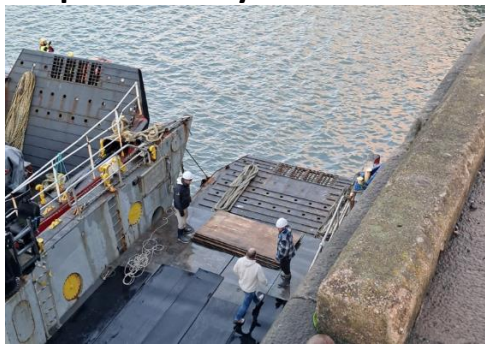
FIG 5 – Bow Ramp Normandy Trader & Normandy Warrior

1.8 The Fire and Rescue service started to prepare for extracting the casualty using a harness, but then a combined reassessment with the other services determined that extraction of the casualty would best be achieved via the NORMANDY WARRIOR's bow ramp and one of the Fire Service's Inflatable Rescue Boats which was deployed to the scene and would effect a transfer of the casualty to a waiting ambulance at the nearby slipway. ('Old Lifeboat Slip'). The Skipper of the NORMANDY TRADER therefore lowered the NORMANDY WARRIOR's bow ramp to the waterline. (FIG 5)

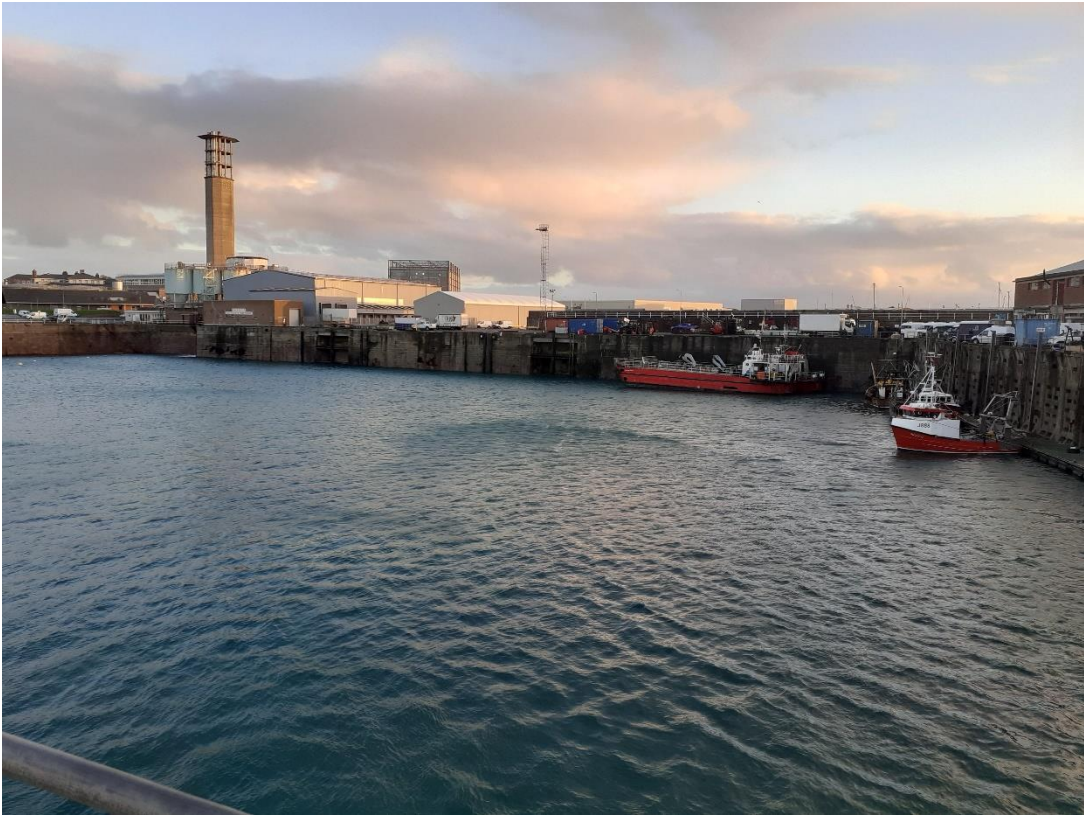
FIG 6 – Victoria Quay- East Cross, West Cross & London Berth

6.9 The ladder used was one of four steel ladders spaced alongside the Victoria Pier covering both East and West Cross berths (see FIGs 6 6A and 6B). All, except for the ladder on the central landing stage which is recessed, are proud of the quay edge and protected by vertical cylindrical fenders.
