INVESTIGATION INTO THE DEATH OF ONE CREW MEMBER OF THE
FRENCH FLAGGED PASSENGER FERRY VICTOR HUGO WHEN
ATTEMPTING TO TRANSFER FROM ANOTHER VESSEL MOORED
ALONGSIDE, WHILST BOTH VESSELS WERE BERTHED AT VICTORIA
PIER, ST HELIER, JERSEY ON 23RD JULY 2023

Passenger vessels *Victor Hugo* and *Granville* moored alongside Victoria Pier, St Helier 23/07/2023

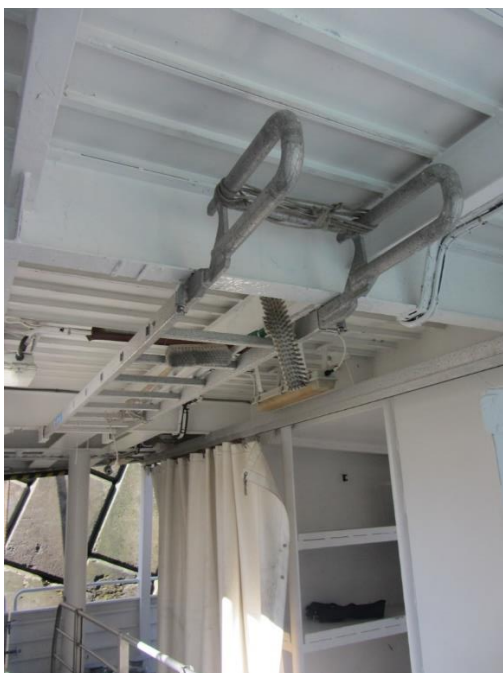
4.2.3 The *Granville* and *Victor Hugo* carry portable ladders for use at berths where fixed access arrangements are not provided or are unsuitable. The use of this equipment where the vessel is subject to significant movement at the berth puts personnel using it at significant risk. It is one of

these ladders that was used to access the *Victor Hugo* from the quayside when the master and crew member returned aboard their vessel.

Vessels ladder used to access the shore when shore facilities are unable to be used.

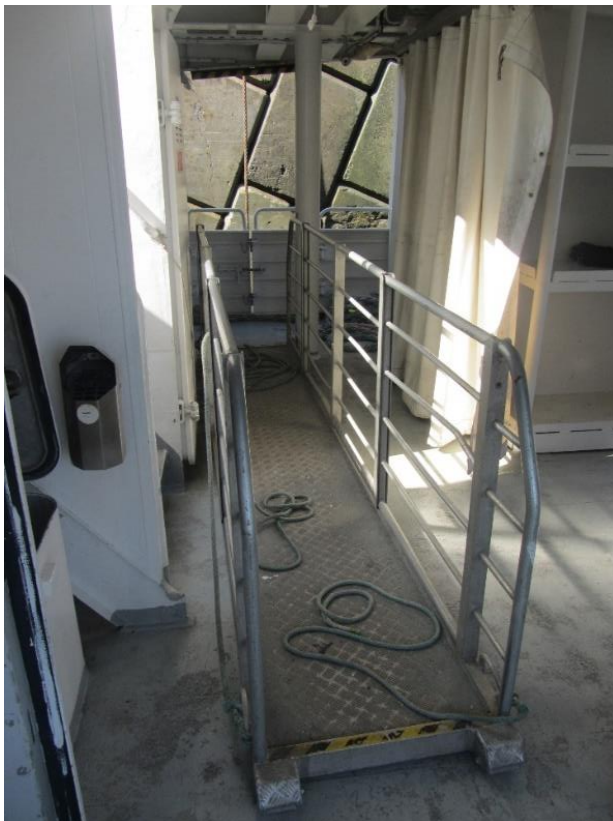
4.3.1 *Victor Hugo* is provided with an aluminium gangway. When rigged and deployed correctly this equipment can provide a safe means of access to another vessel of similar size, deck height and configuration. The gangway could also be used as a safe means of access to the shore, dependent upon the height of the quay relative to the vessels deck. The gangway is located on the aft part of the vessel immediately behind the passenger accommodation. Gates are provided in the vessel's bulwarks to enable the gangway to be rigged directly from the deck level.

4.3.2 Although (due to the weight of the gangway) it is not a single person operation, a small number of crew members could deploy the gangway. If there is movement between vessel and quayside, or between vessels the movement between gangway and vessel structure creates noise. If vessel motion is extreme, it is also possible that the gangways and / or vessel structures could be damaged. Statements from crew members suggest that this noise, which causes disturbance to those staying aboard the vessels overnight was the reason why the gangway was not rigged between the vessels on the night of the accident.

Aluminium gangway

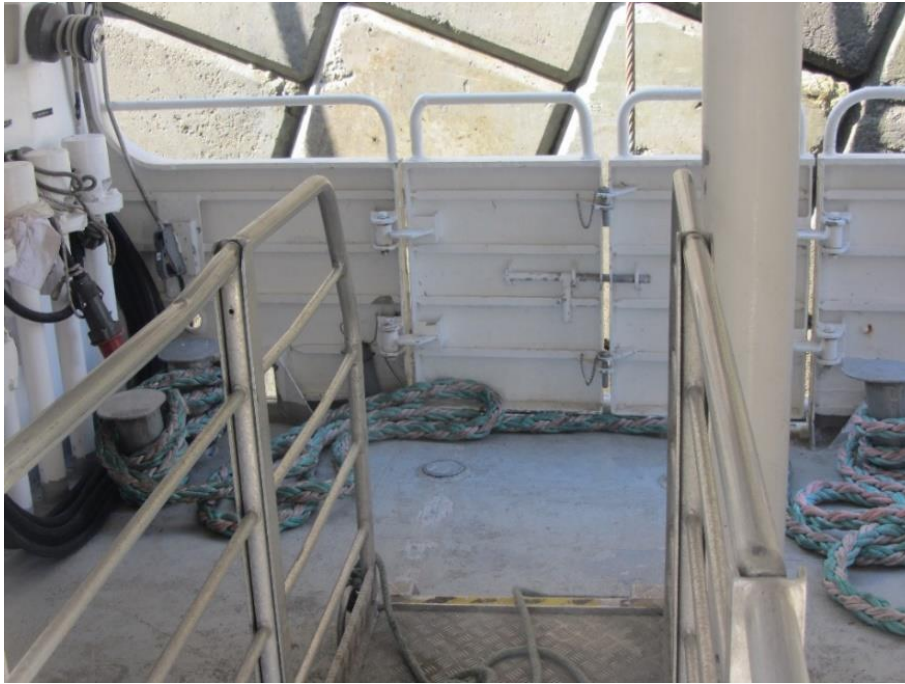
Gates in bulwarks for the gangway to interface with another vessel or the shore

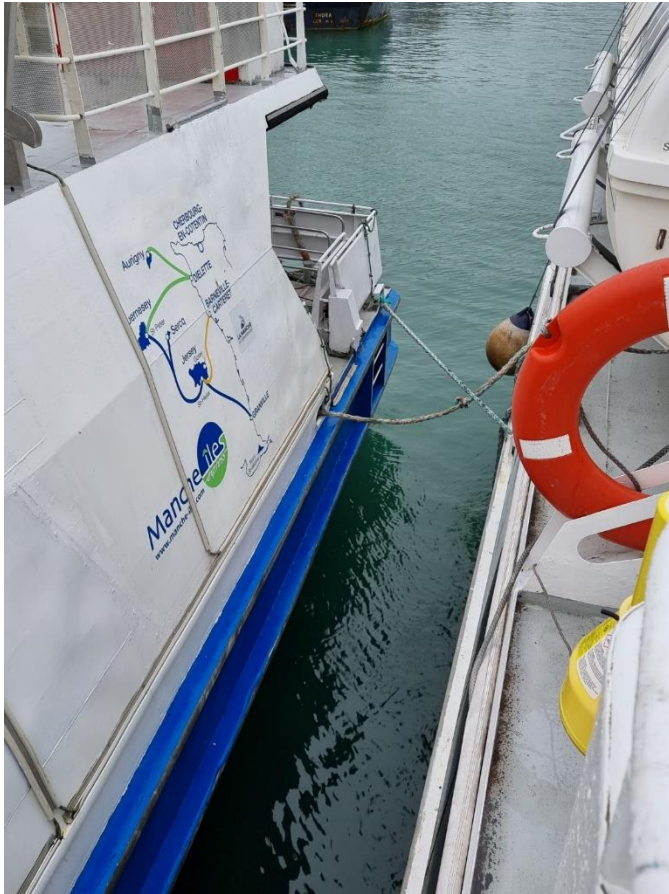
4.4.1 The *Victor Hugo* was made fast alongside the Victoria Pier. The *Granville* was secured to the *Victor Hugo* with two long mooring lines forward (spring and fore line) and “two short lines crossed on the back” according to the master’s statement.

4.4.2 Supplementary mooring lines were not taken from the *Granville* to the Victoria Pier. When questioned, the *Victor Hugo*’s master expressed the opinion that rigging these lines would not have made significant difference to the motion of the vessels. However, when rafting small vessels from an alongside berth, it is good practice to rig shore-lines from the outboard vessel to restrict movement and balance the loads between all mooring lines. This becomes especially important in periods of strong winds. It is possible that if shore lines from the *Granville* had been rigged in addition to the lines securing both vessels together, overall movement of the two vessels might have been reduced and therefore it would have been easier (and quieter) for a gangway to be rigged and maintained between the vessels.

Arrangement of the vessels stern mooring at the time of the port state control inspection on 23 July 2023
